FIELD TRIP GUIDEBOOK ON

ENVIRONMENTAL IMPACT OF CLAYS ALONG THE UPPER TEXAS COAST

Clay Minerals Society 28th Annual Meeting
Houston, Texas

For the
Clay Minerals Society 28th Annual Meeting

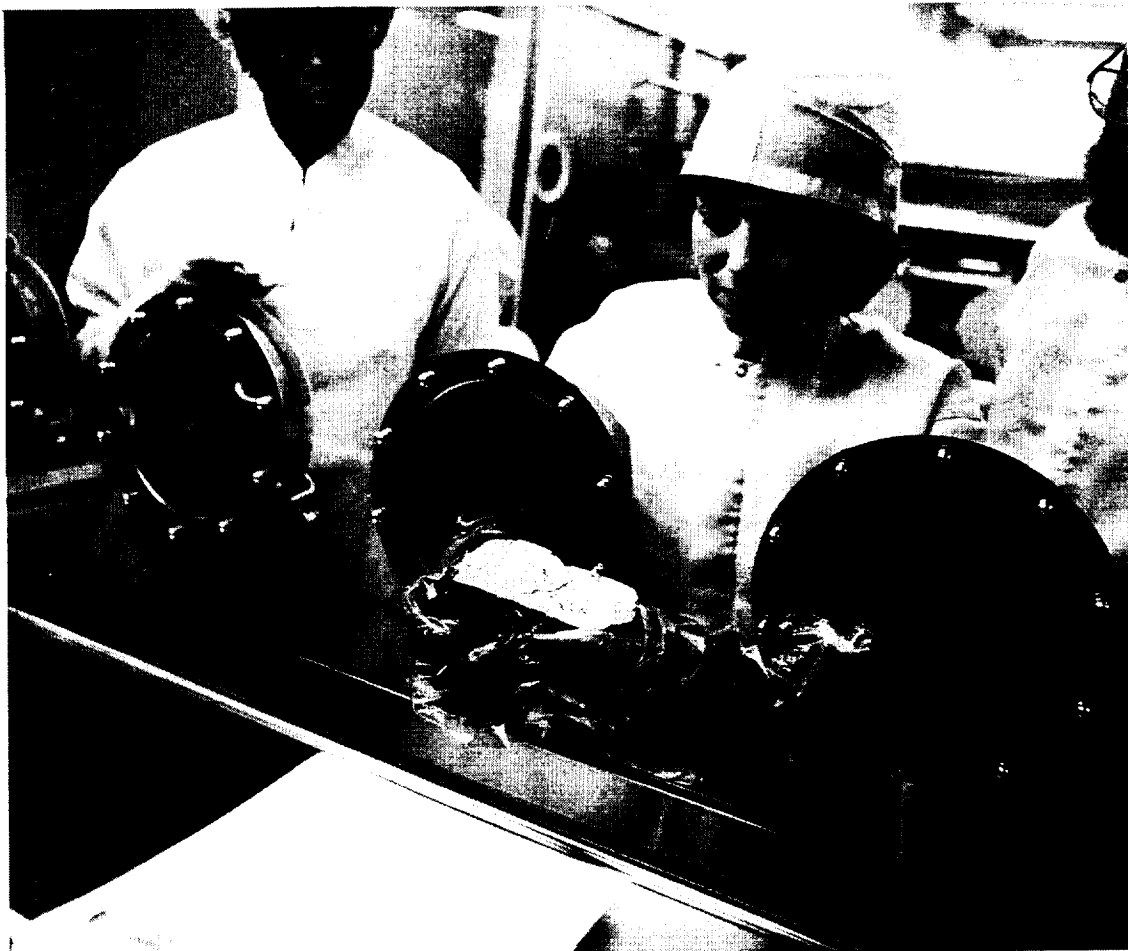
FIGURE 2-3. This sample is one of many collected on the lunar surface (approximately 382 kg of lunar samples were collected) and brought back to Earth during the six Apollo missions. The majority of the Apollo samples are stored in the Lunar Sample Building located at the Johnson Space Center (NASA Photo S82-26777).

purpose for the Lunar Sample Building. Equally important, however, is making the collection available for scientific study and education because it is these activities that give the samples their true value (Fig. 2-3). As methods of research continue to improve and as knowledge is gained, previously unformulated questions arise that require new studies. Enough of the samples must be preserved so that material will remain available in unaltered condition to make such new studies possible.

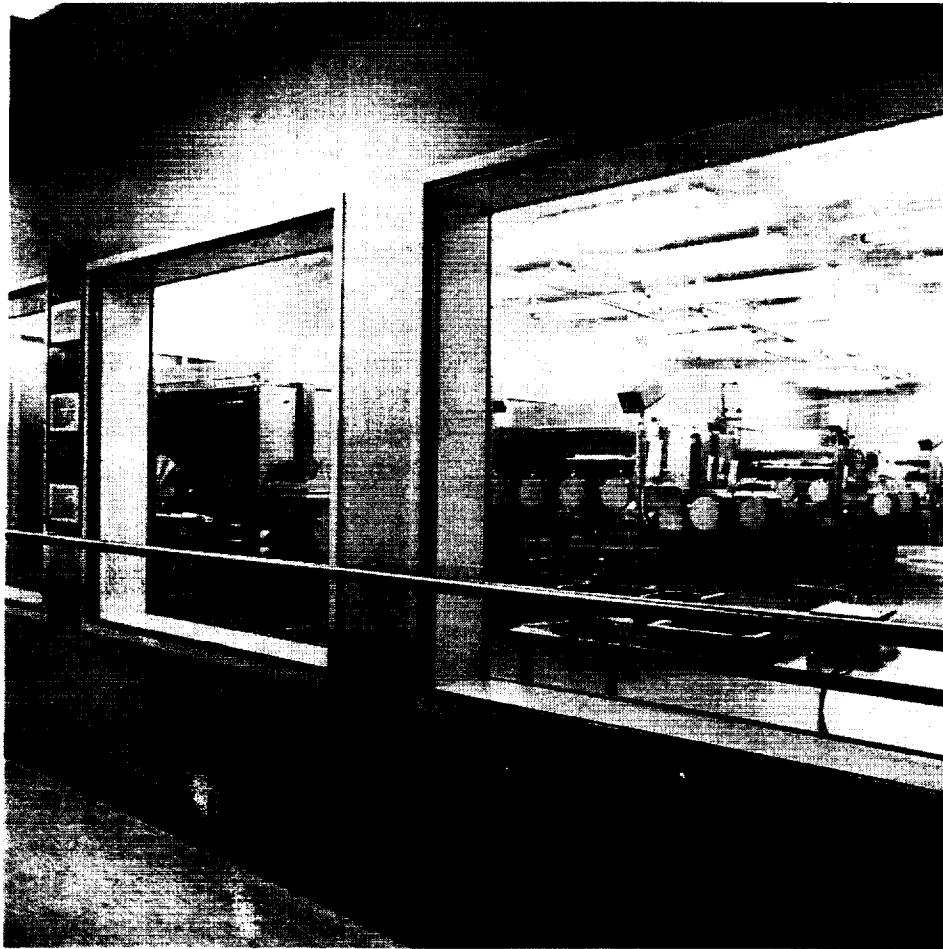
FIGURE 2-4. The lunar Sample Building is the chief repository for the Apollo samples (NASA Photo S83-42819).

The Lunar Sample Building consists of storage vaults for the samples, laboratories for sample preparation and study, a vault for all sample data and records, and the machinery to supply nitrogen to the cabinets and to maintain the clean environments of the sample laboratories and vaults (Fig. 2-4). The vaults are designed to protect the collection of samples against theft, and from damage by natural hazards such as tornados and hurricanes. Thick walls of reinforced concrete are lined on the inside by welded steel plates to keep out moisture. The heavy vault doors remain closed except for removal or storage of samples. All pipes and openings into the

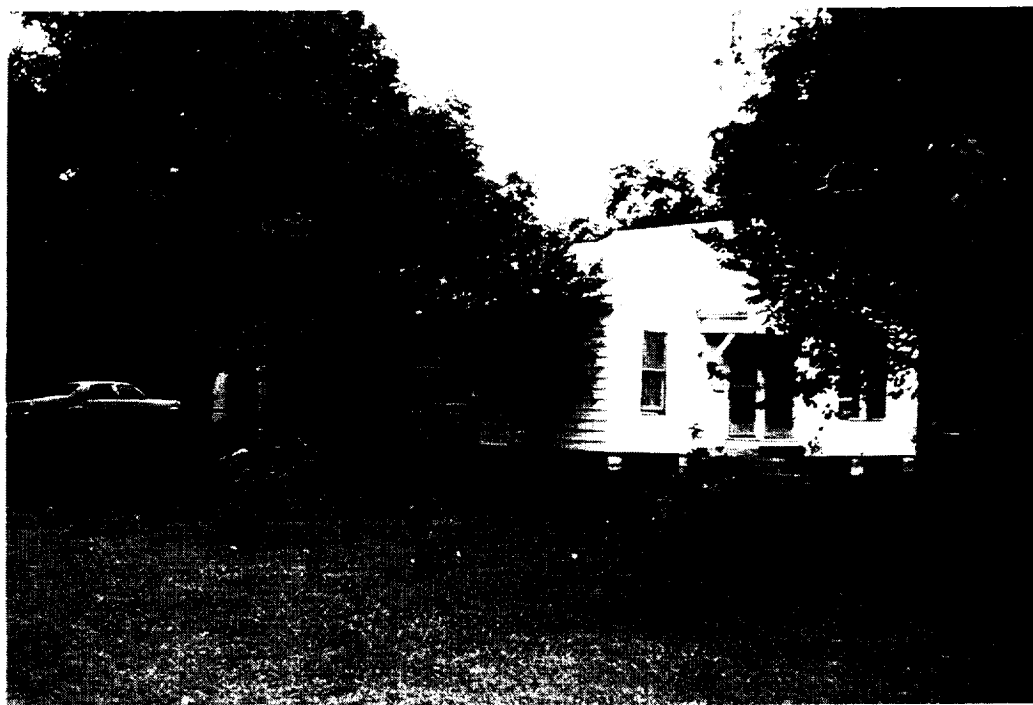
FIGURE 3-3. Residence that straddles the Wooster fault in Baytown.

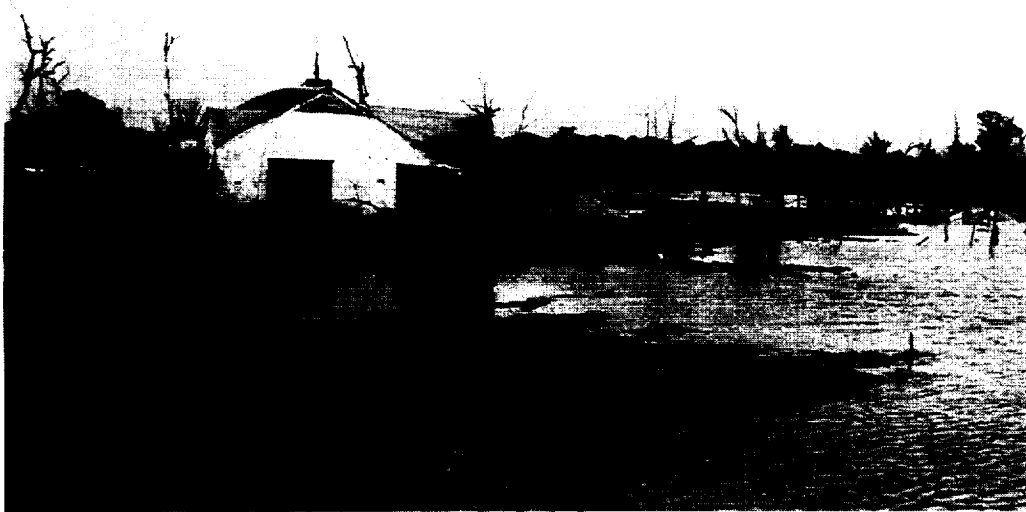
FIGURE 3-4. Submerged house in the Brownwood subdivision, Baytown, Texas.

A total of over 8 feet of subsidence has occurred since 1938 when building first began in the Brownwood Subdivision. Elevation at that time was about 10 feet (3.3 m) above sea level. At times in the past the rate of subsidence in this area was measured in inches per year. By 1961 when Hurricane Carla hit the Houston area the subdivision had lost 4 feet of elevation. Homeowners fought periodic flooding due to high tides, high winds, and storm surges until 1983 when

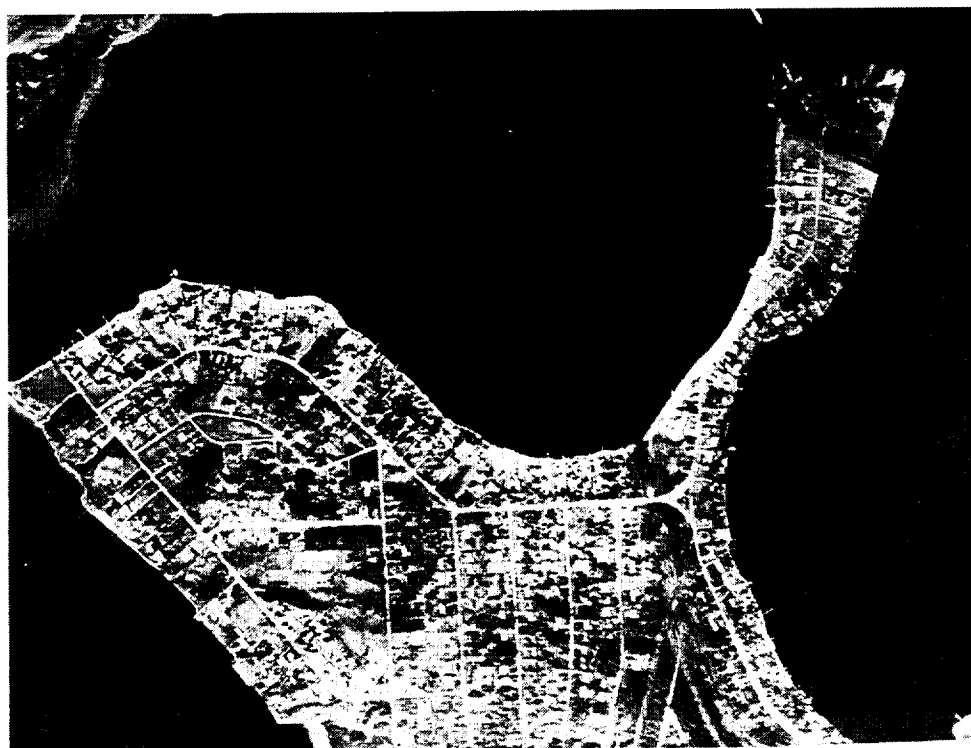
FIGURE 3-5. Aerial view of the Brownwood subdivision in 1964.

The progressive subsidence of Brownwood is clearly demonstrated by comparing the aerial photo in Figure 3-5 with the present view. In the 1940s, a

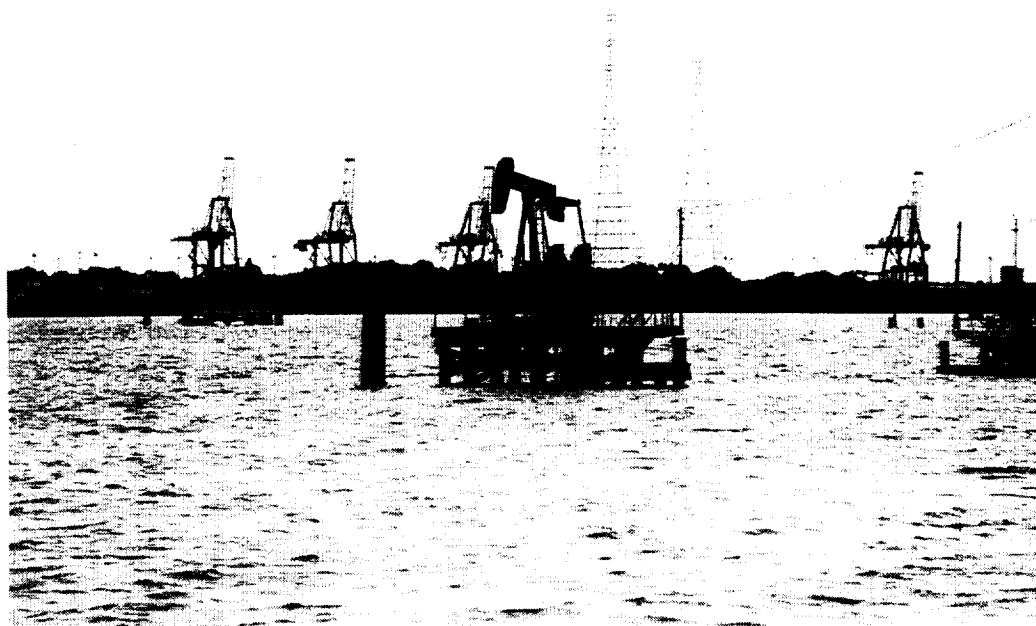
FIGURE 3-8. Submerged oil wells in the Goose Creek Oil Field near Baytown, Texas. These wells were once located on dry ground until subsidence in the oil field left them in their current, partially-submerged state.
